## CONSERVATION TREATMENT OF MURAL PAINTINGS IN VIRUPAKSA TEMPLE, HAMPI

Saroj Kumar Pandey<sup>1\*</sup>

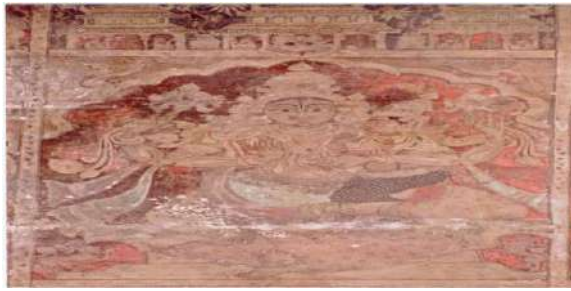
Fig.1a - Before Conservation

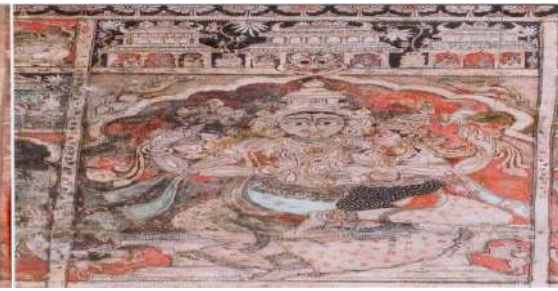
Fig.1b After Conservation.

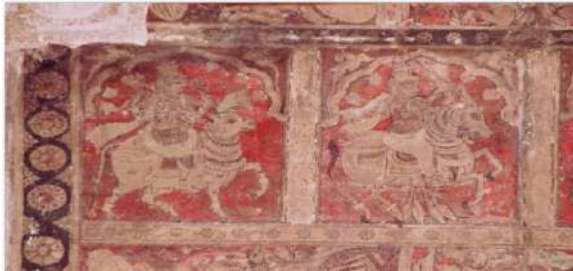
Fig.2a - Before Conservation

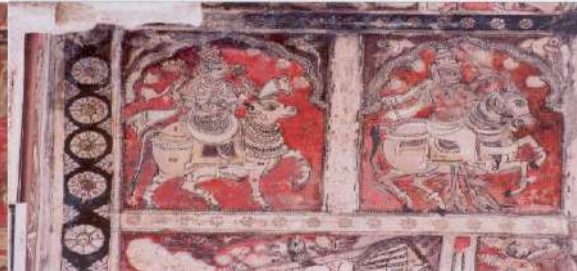
Fig.2b - After Conservation.

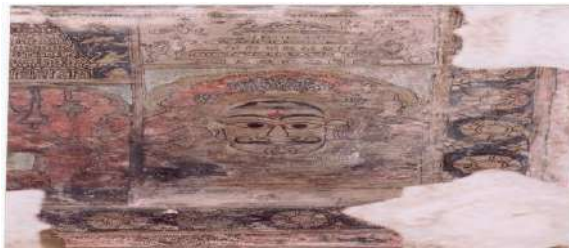
Fig.3a - Before Conservation

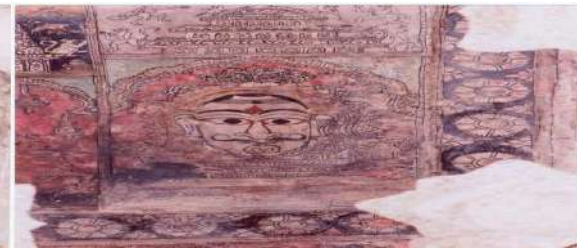
Fig.3b - After Conservation.
